Manhole Inspection Summary

Manhole # S09CC1010MH

Location Address: **GRANTLEY AVE ALLEY**

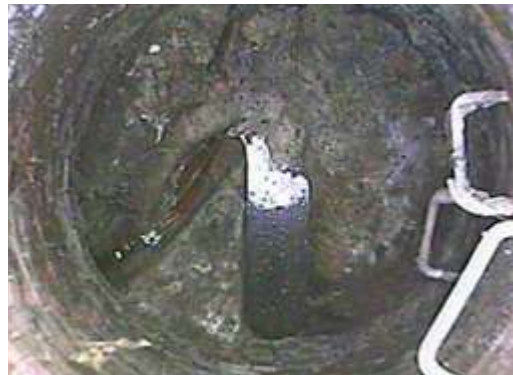
Defect 1

Surcharge ☒ **Evidence Of Surcharge** Depth: **5** (ft.) ☐ Active Surcharge Present

CORRODED STEP AND EVIDENCE
SURCHARGE

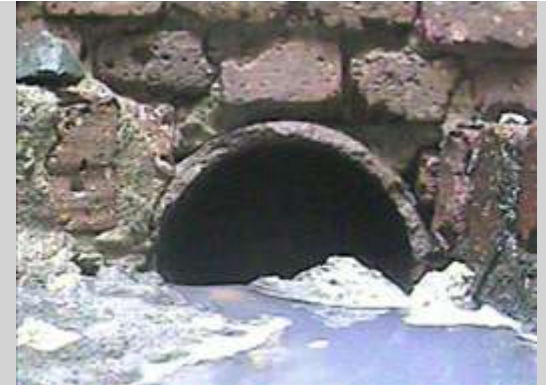
12 O'Clock Outflow

8 in. Circular Gravity Sewer
Pipe Out @ 12 O'Clock

Pipe Height: (in.) Direct
Pipe Material: **Clay** ☐ Pipe Lined
Invert Depth: **7.08** (ft.) Flow Characteristics: **Slow**
Deposits: ☐ None ☐ Mud ☒ **Sludge** ☐ Debris ☒ Grease
Silt Depth: **5** (in.) Deposits Extent: **Heavy**
Infiltration: **None** Pipe Seal Cond: **Sound**

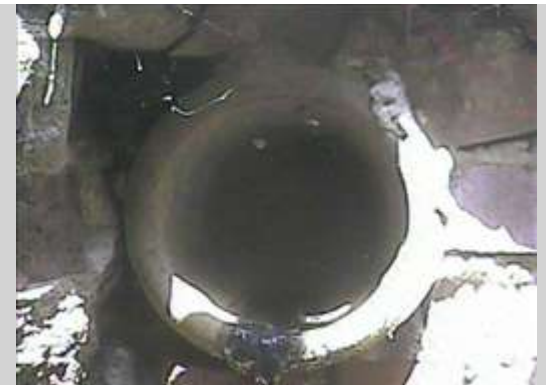
3 O'Clock Inflow

6 in. Circular Gravity Sewer
Pipe In @ 3 O'Clock

Pipe Height: (in.) Direct
Pipe Material: **Clay** ☐ Pipe Lined
Invert Depth: **3.10** (ft.) Flow Characteristics: **Slow**
Deposits: ☒ None ☐ Mud ☐ **Sludge** ☐ Debris ☐ Grease
Silt Depth: (in.) Deposits Extent:
Infiltration: **None** Pipe Seal Cond: **Sound**

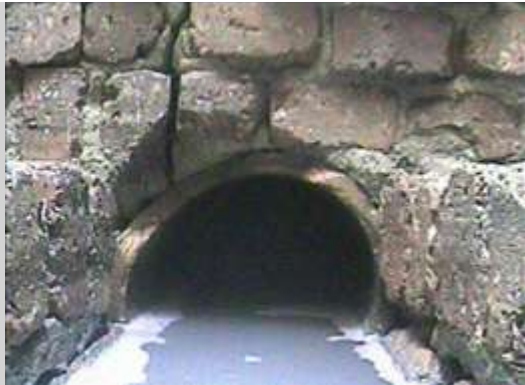
6 O'Clock Inflow

Deposits: ☐ None ☐ Mud ☒ Sludge ☒ Debris ☐ Grease

Silt Depth: **5** (in.) Deposits Extent: **Heavy**

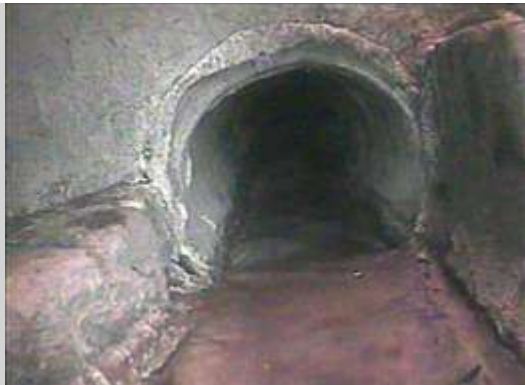
7 O'Clock Inflow

Deposits: ☒ None ☐ Mud ☐ Sludge ☐ Debris ☐ Grease

Infiltration: **None** Pipe Seal Cond: **Sound**
